Facility:

Ashland Performance Materials
28015 Christopher Columbus Boulevard
Philadelphia, PA 19148

Date of Inspection:

April 29, 2014

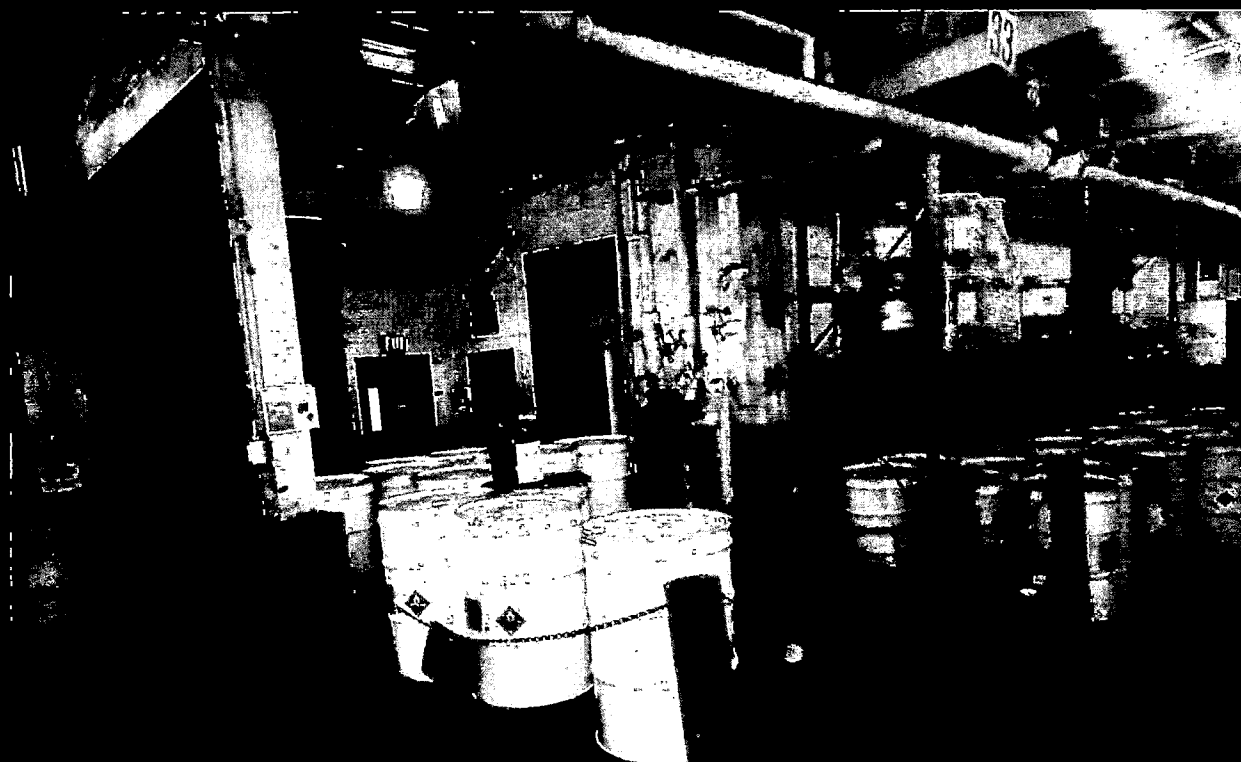
Photo 1

In this building is where APM has their 90 hazardous storage area. I observed about 9 total 55 gallon containers in this area; see photo 1. Only 8 were labeled as HW and each had an accumulation date less than 90 days at the time of the inspection. The laboratory had one SAA container which contained acetone, toluene and acidic acid waste. This SAA container is then taken to another container which is outside between buildings 10 and 76. This container is also considered a SAA for collecting condensation from the process venting system. This container is labeled as HW and no accumulation date was observed. The Label had the waste codes D001, F003, & F005.

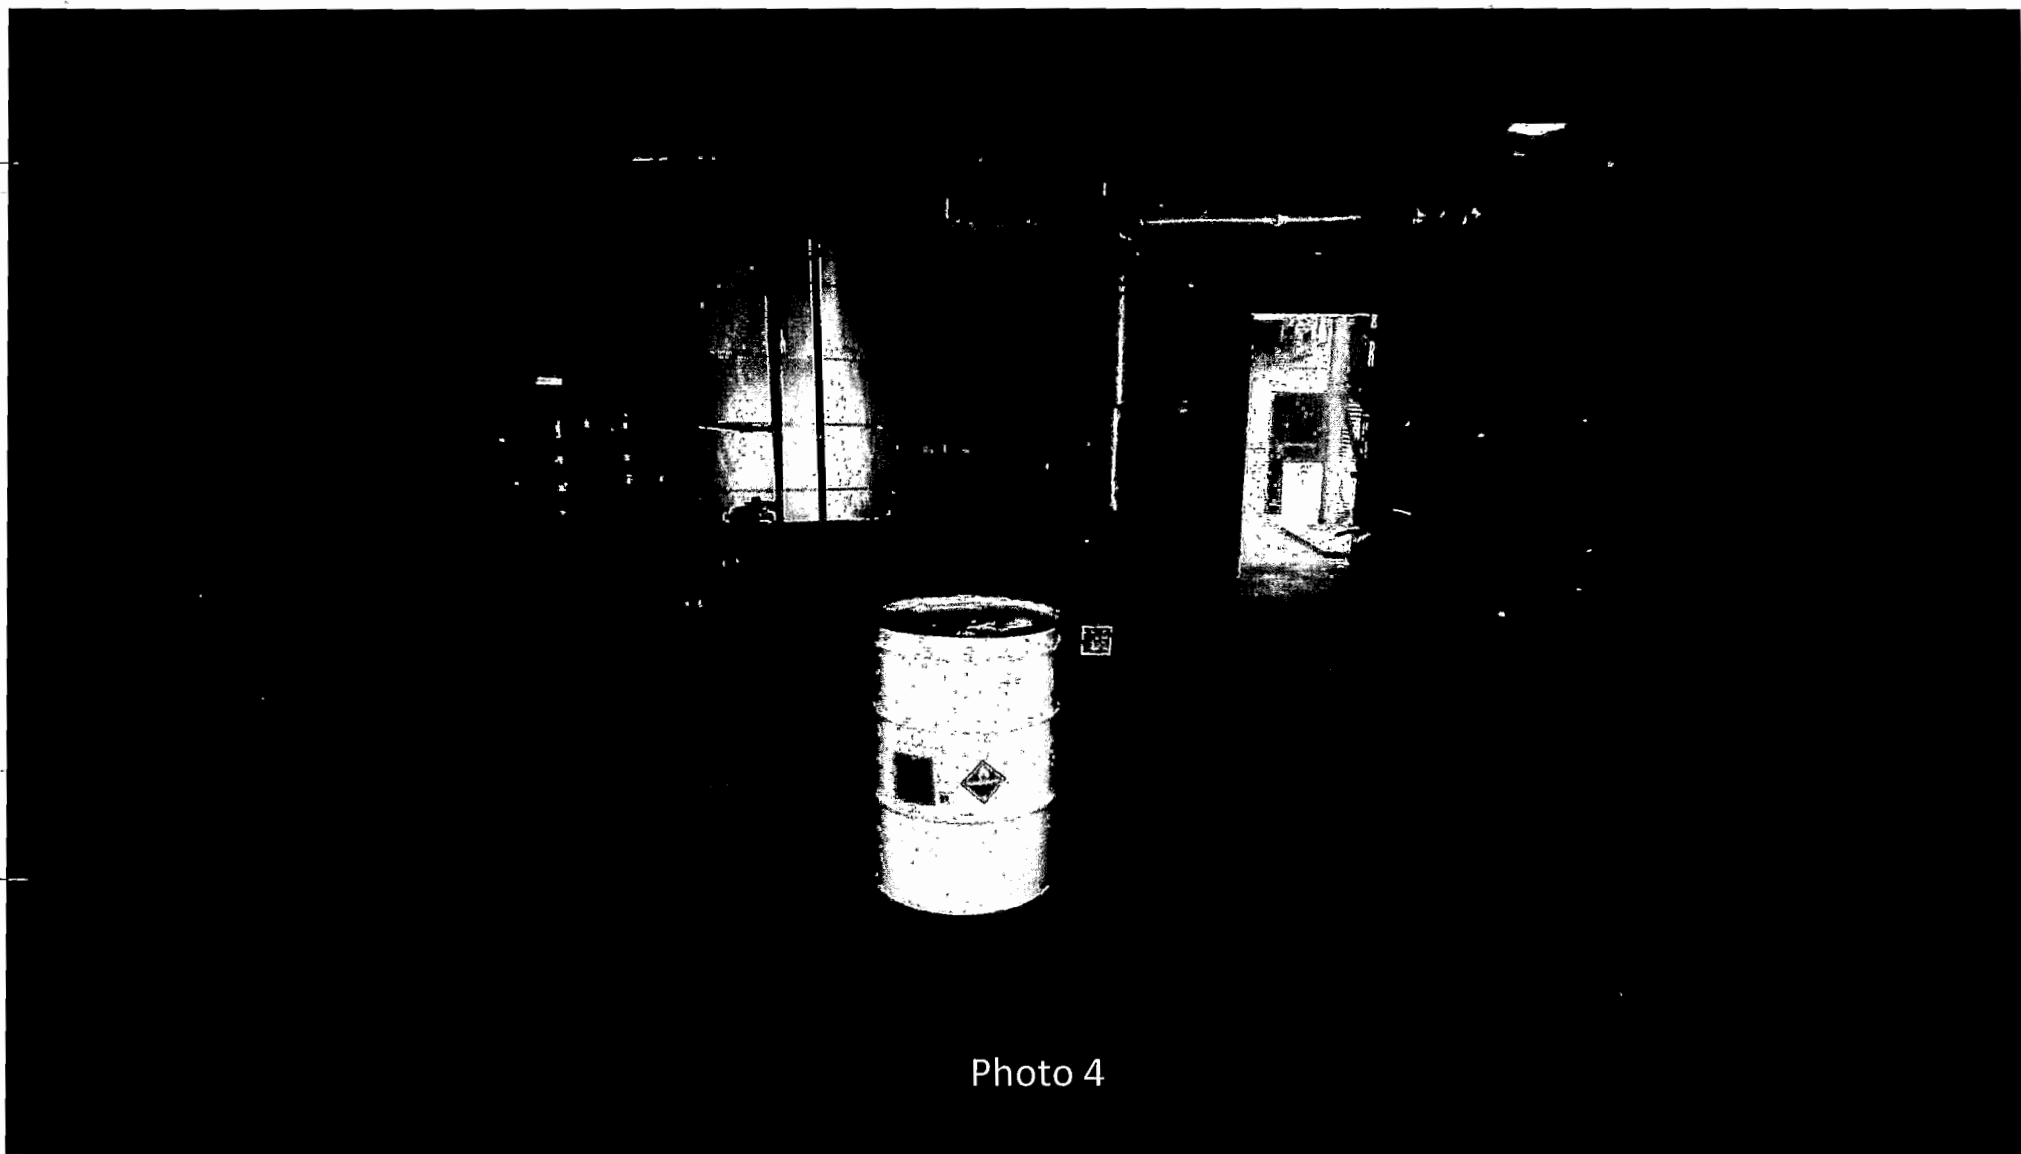
Photo 4

Mr. Weisbrod escorted me throughout the facility showing me where the raw materials come into the site and where it is stored until needed. The process reactors and blend tanks are located in Building 76. Three of the five reactors, R1, R2, & R3, are for polyester production while the others, R4 & R5, are used for vinyl ester production. There are also 9 blend and 4 thin tanks located in Building 76. Next to reactor 4 I observed a 55 gallon container with a hazardous waste label used as a satellite accumulation; see photo 4. This container collects styrene

contaminated waste from the strainers. These strainers strain the product just before it enters the blend tanks from the reactors. The 3rd floor had 2 containers being used as SAA for used rags which were labeled and contained waste codes D001 & F003. One container was about 20 gallons and the other was 55 gallons. There was another 55 gallon container used as a SAA for collecting wastewater from cleaning the floor. APM uses a product called PE-12 which is soluble in water. The container was labeled and contained the waste code D002.
